Office of Child Support Services (OCSE)  
400 East Capitol Street

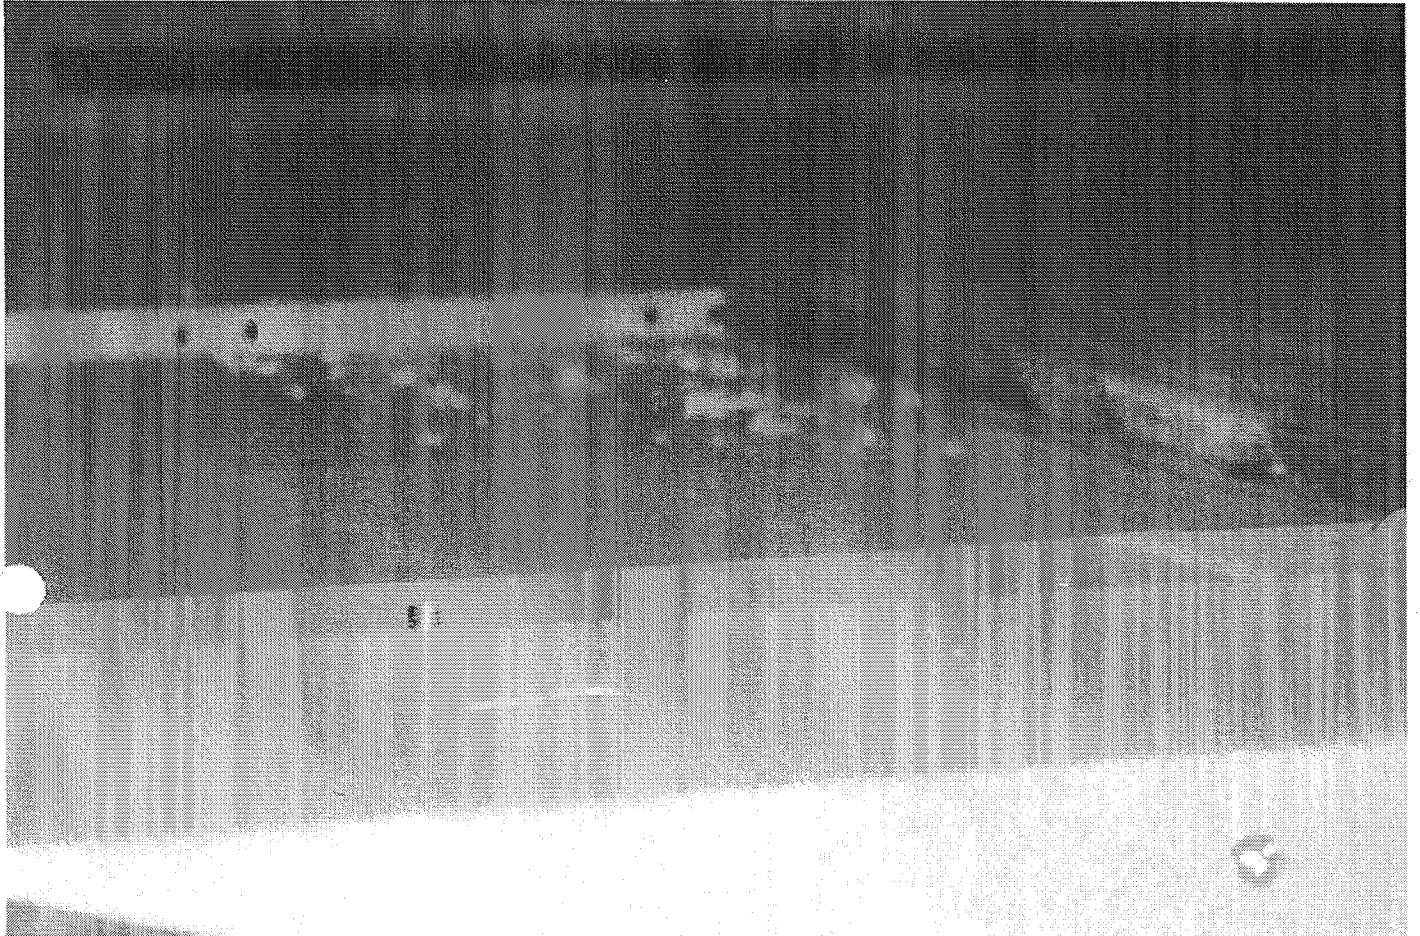
65. 6th floor center suite 602 - Close-up of fireproofing debris on top of suspended ceiling

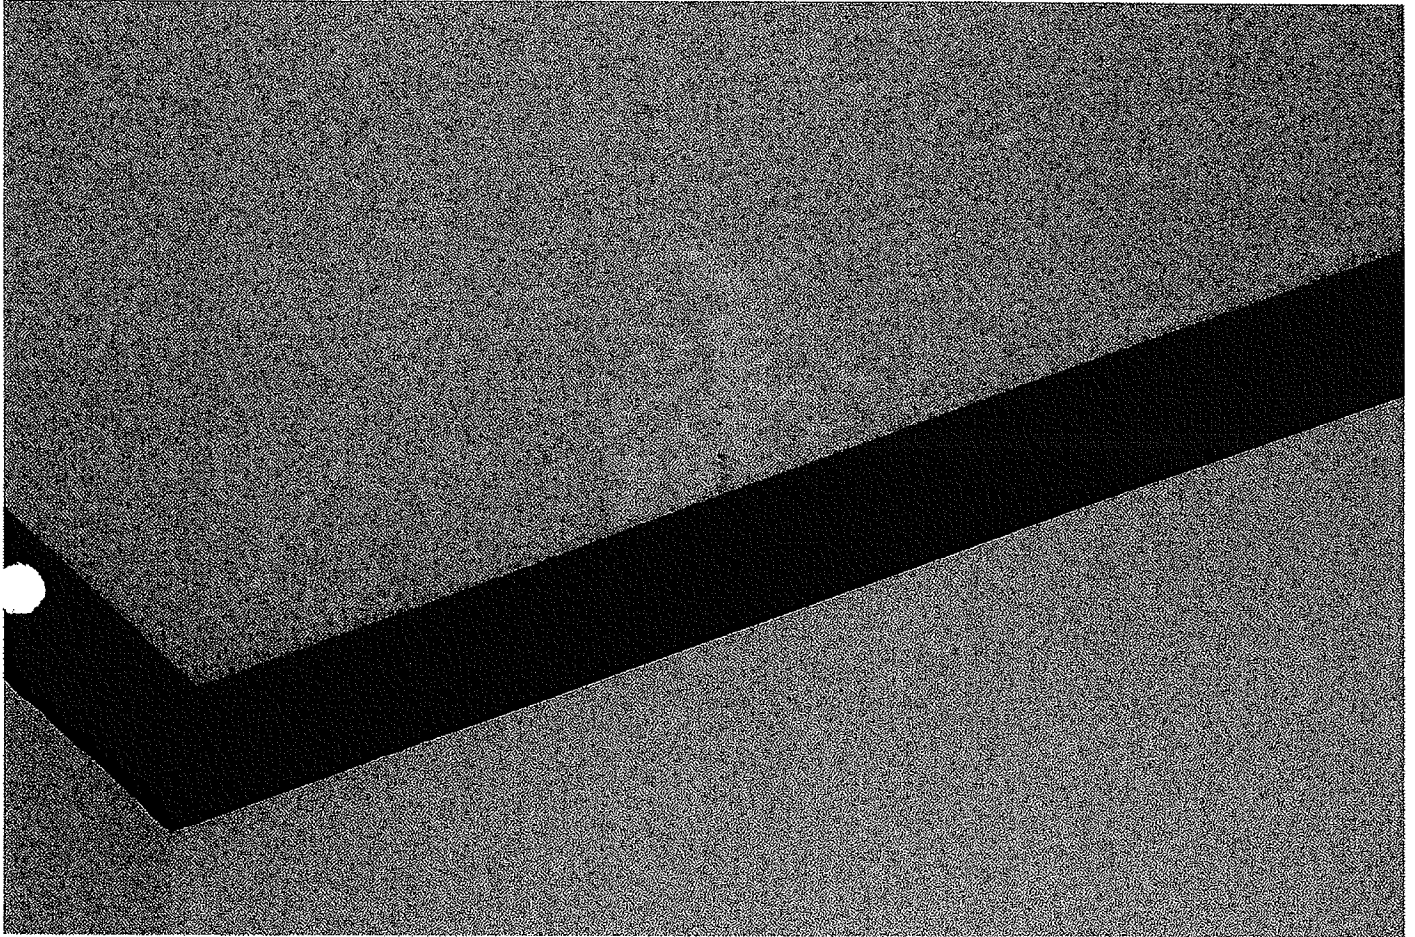
66. 1st floor west office areas - Damaged acoustical plaster in lobby

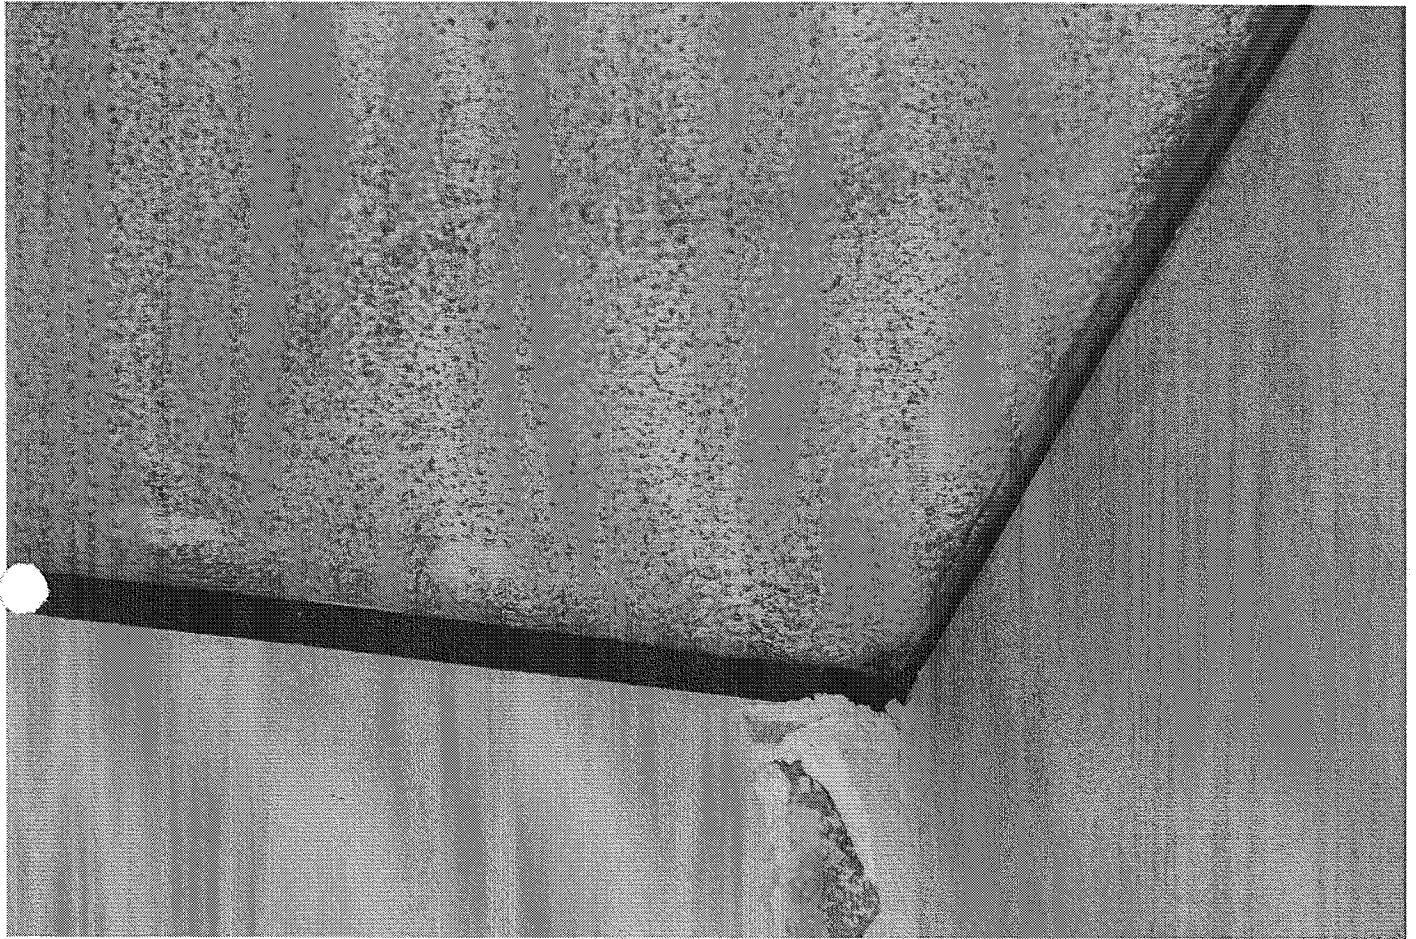
67. 1st floor west office areas - Close-up of water damaged acoustical plaster in lobby
